Field Report (1 of 2)

FIT Deployment In Support of SR 530 Washington State Mudslide & Flooding Disaster (WA-4168-DR)

Field Report (2 of 2)

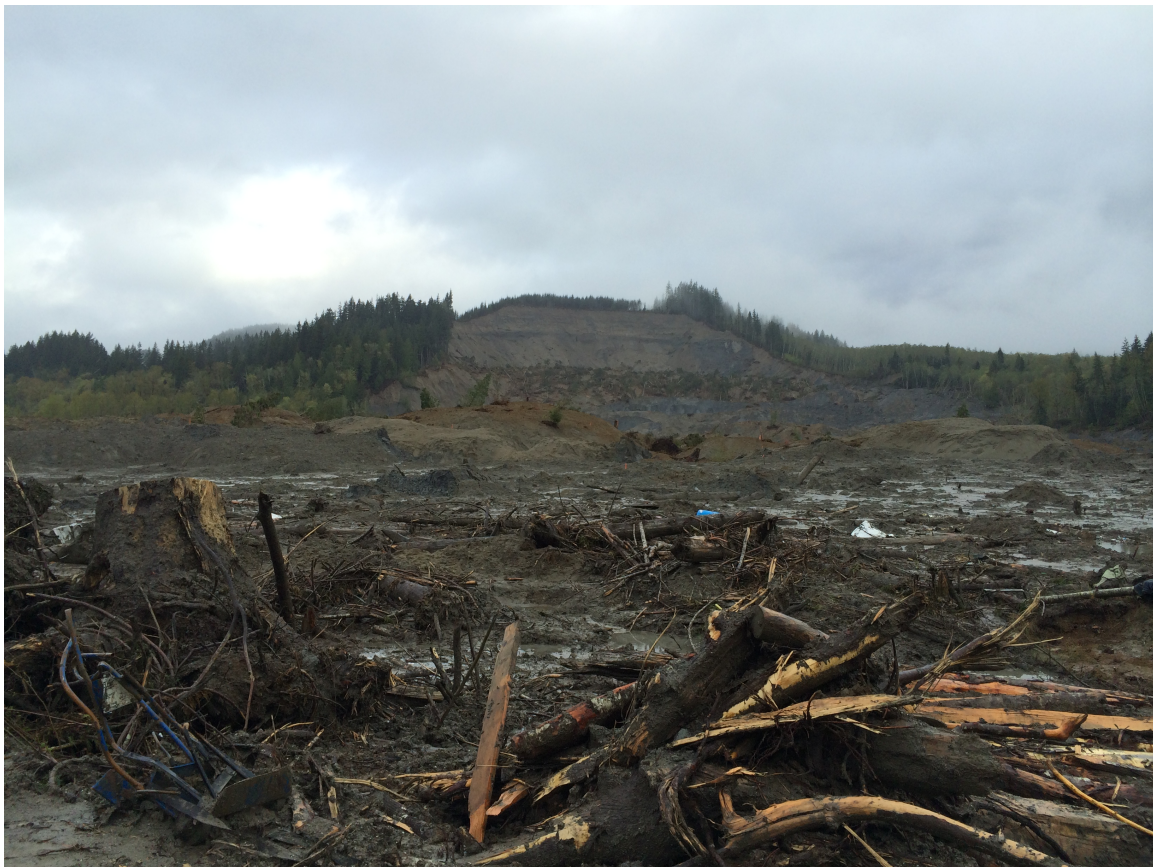
Looking at the collapsed hill terrace and mudslide debris field from State Road 530.

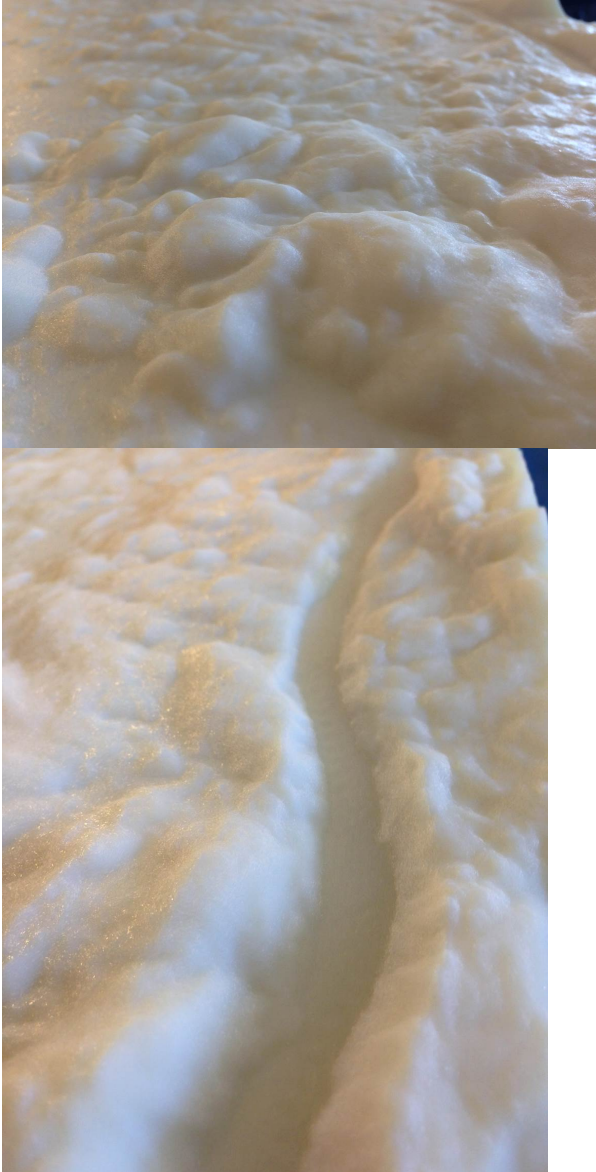
The model has been printed white, as shown in the image below.

Close up view of the first 3D print's terrain features: Deposited mud and debris piles on the left; river on the right.

Autodesk's Objet 500 Connex 3D printer. The 3D design is entered into the machine and hot polymers are layered until the shape is complete. The model was to be printed in two sections. Only half of the total model (the left side) was printed because the Objet 500 Connex bed is 50x40cm or 20" inches, and the total model exceeds that size. Due to the experimental nature of this endeavor, it was decided that one side would be made available for the engineers to view before printing the other side. The print was completed on May 15, 2014. It was shipped to FIT member Frank Sanborn in Seattle who handed it over to Owen Carter, Deputy Director/County Engineer for Snohomish County Department of Public Works.

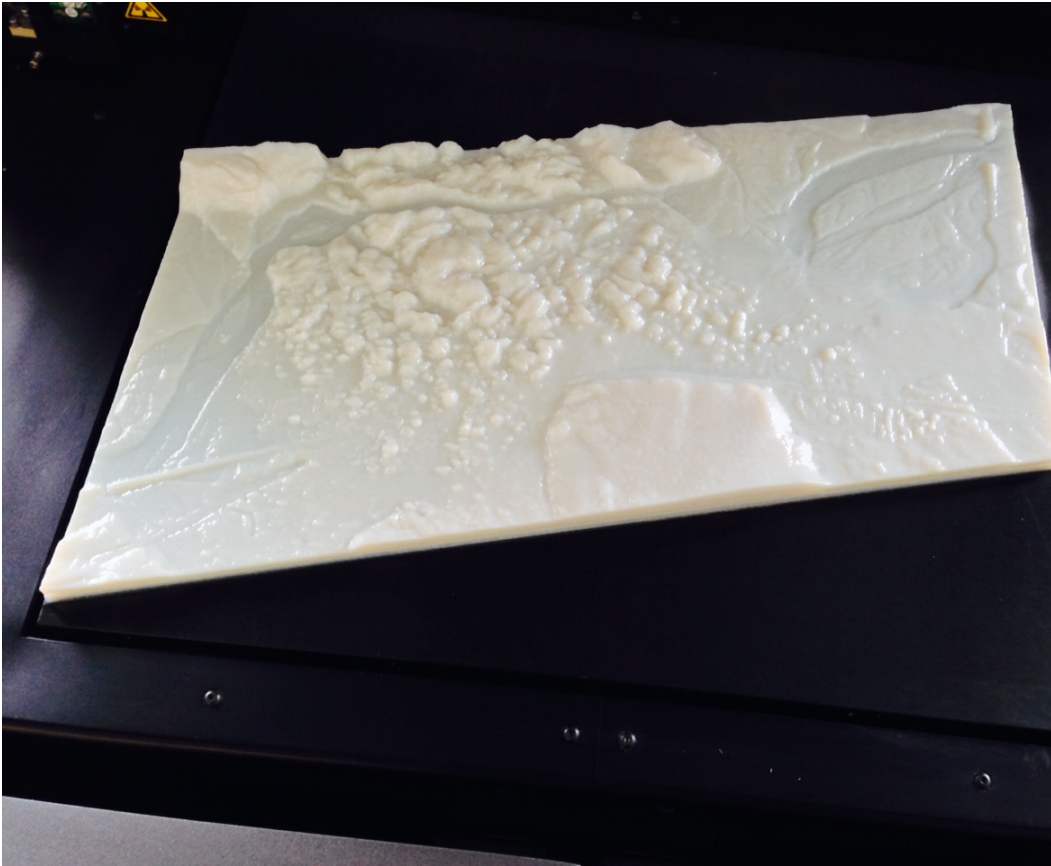
After delivering the 3D printed model to Snohomish County Department of Public Works, the engineers identified an error with the 3D printed model. The model was inverted, or a mirror image of the terrain. This error was due to the wrong reading of the coordinates from the scan files in AutoCAD Civil 3D. The issue was corrected and a second 3D printed model of the mudslide was produced by Autodesk (see image below). The correct model was shipped to FIT member, Frank, who delivered it to August 1, 2014, to Steven Thomsen and Owen Carter. The correct model was well received. Engineers immediately began discussing placement of excavating equipment and how current terrain features may affect future flooding events.

The second 3D print – the corrected model.
